Spa Hills Farm Inc.  
2223 Yankee Flats Road,  
Salmon Arm, BC

**Re: Warning Letter**

On July 16th, 2024, Ministry of Environment and Climate Change Strategy (Ministry) Environmental Protection Officer Rebecca Benham (Ministry Staff) conducted an on-site inspection of the composting facility operated by Spa Hills Farm Inc. (Spa Hills), located at 2223 Yankee Flats Road Southwest, Salmon Arm, BC (Facility). The purpose of the inspection was to verify compliance with the Organic Matter Recycling Regulation (OMRR), under which Spa Hills is registered with authorization 104962 (Authorization), as well as to follow-up on complaints regarding the processing and storage of compost. The Authorization was first issued on June 29th, 2010, and last amended on February 2nd, 2016.

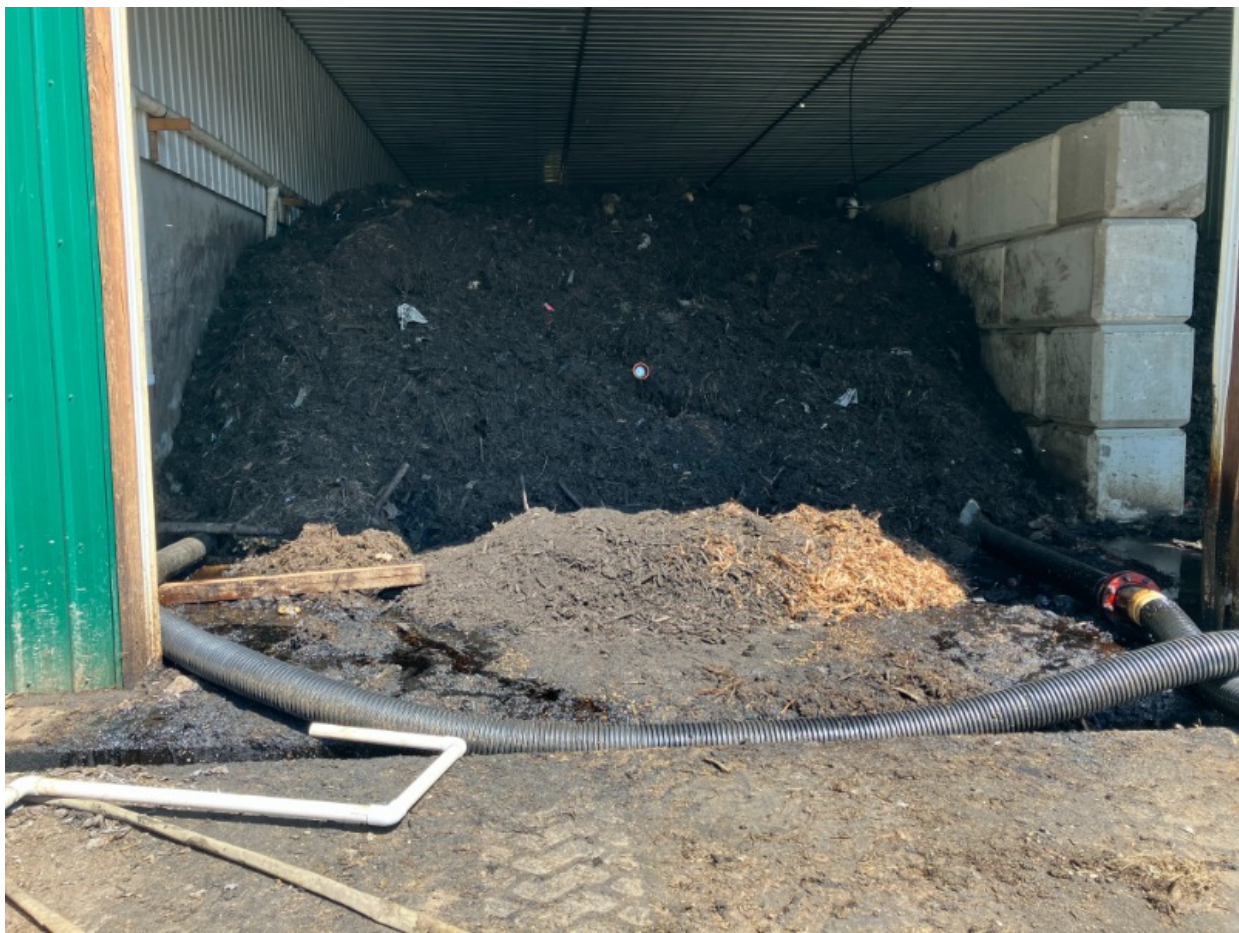
During the on-site inspection, Ministry Staff observed that the receiving, processing and curing areas of the composting facility were located on concrete (Photos 1, 2 and 3). However, Ministry Staff observed that the compost storage area at the Facility was not located on an impermeable surface and did not prevent the release of leachate into the environment.

The Co-Owner informed Ministry Staff that all composting and storage areas were located on a sloped surface. During the on-site inspection, Ministry Staff observed that the receiving, processing and curing areas have a sloped area where leachate drains into a 4500L collection system and the Facility recycles the leachate back into the composting process (Photos 1,2 and 4).

Photo 1. Processing and curing areas of the composting facility, located on concrete and covered with a leachate collection system.

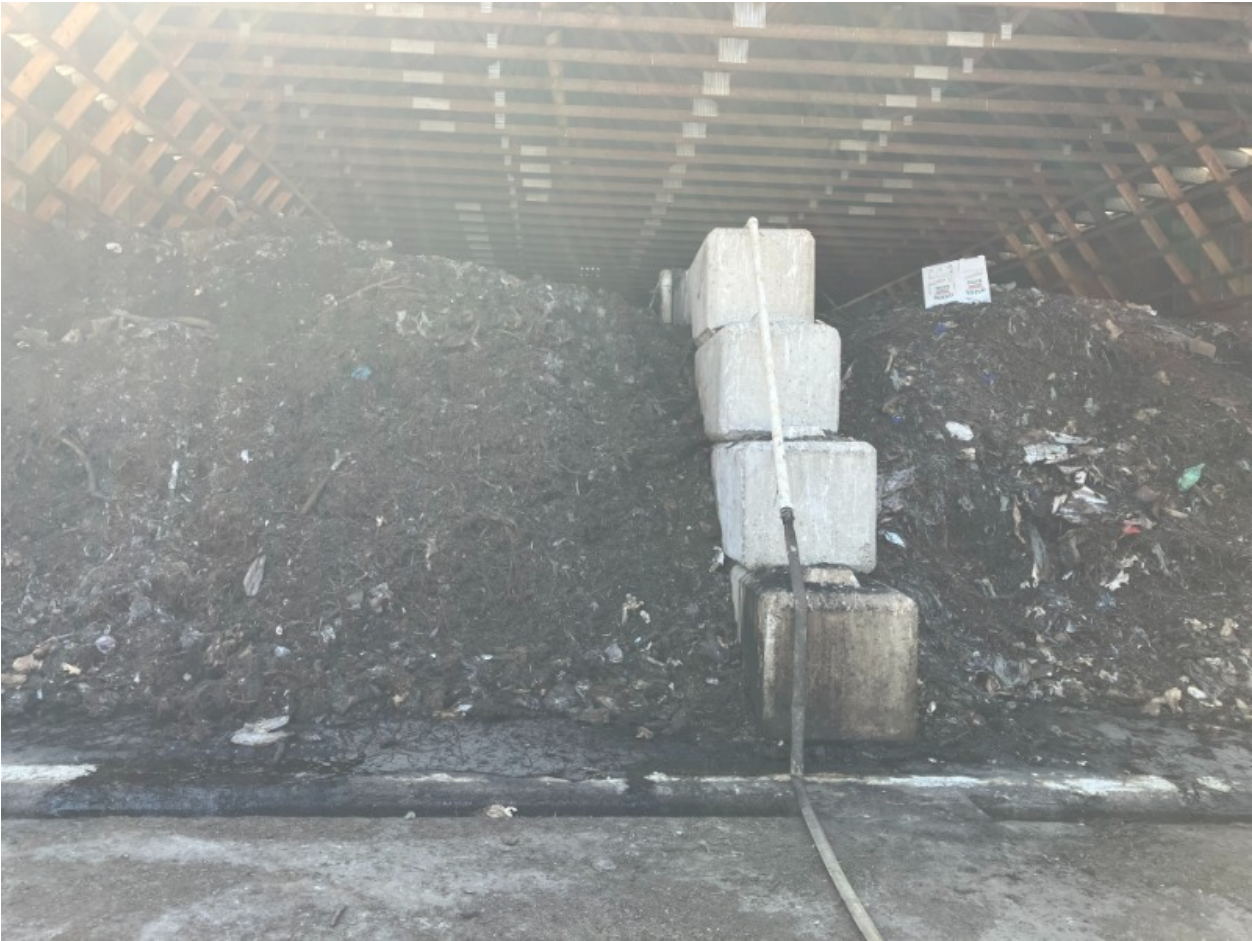
Photo 2. Receiving, processing and curing areas of the composting facility are located on concrete and covered.

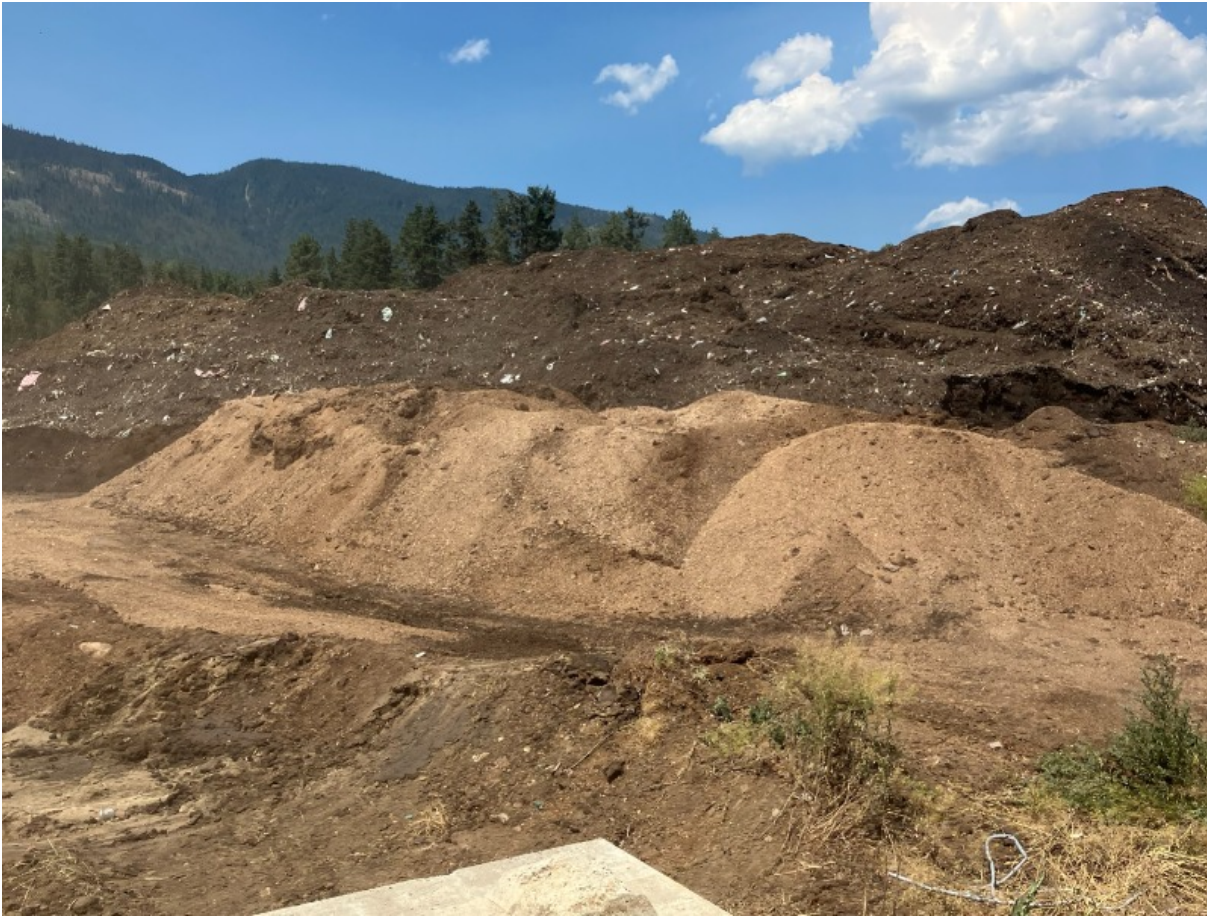
Ministry Staff observed that the receiving, processing and curing areas of the composting facility were covered and sloped to prevent water from collecting around the organic matter and compost. However, the storage area at the Facility did not have a roof, cover or a prepared surface designed to prevent the surface collection of water around the base of organic matter (Photo 3).

Ministry Staff observed that the receiving, processing and curing areas of the composting facility were covered and on a prepared surface to prevent run-off from entering the areas. However, the storage area at the Facility was not covered or on a prepared surface (Photo 3).

Photo 3. Compostable and recyclable materials, that have gone through Schedule 2 and 3 of OMRR, storage area.

Ensure that the receiving, storage, processing and curing areas are located on an impermeable surface that is capable of withstanding wear and tear from normal operations and that will prevent the release of leachate into the environment.

Ensure Spa Hills has a roof, cover or a prepared surface designed to prevent the surface collection of water around the base of organic matter and compost within the storage area.

Ensure Spa Hills has a roof, cover or a prepared surface designed to prevent run-off water from entering the storage area.

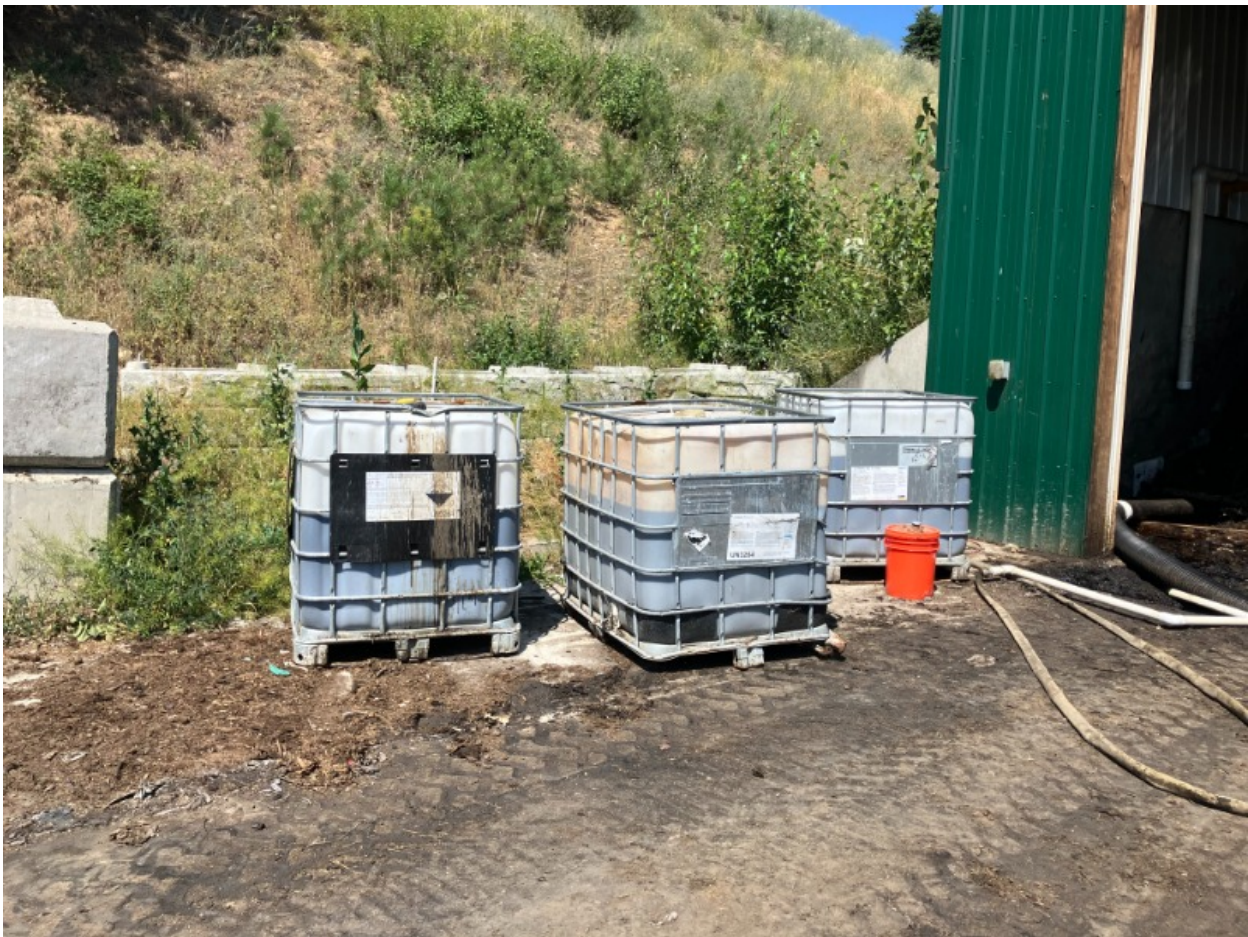
Photo 4. 4500L leachate collection system Facility recycles the leachate back into the composting process.

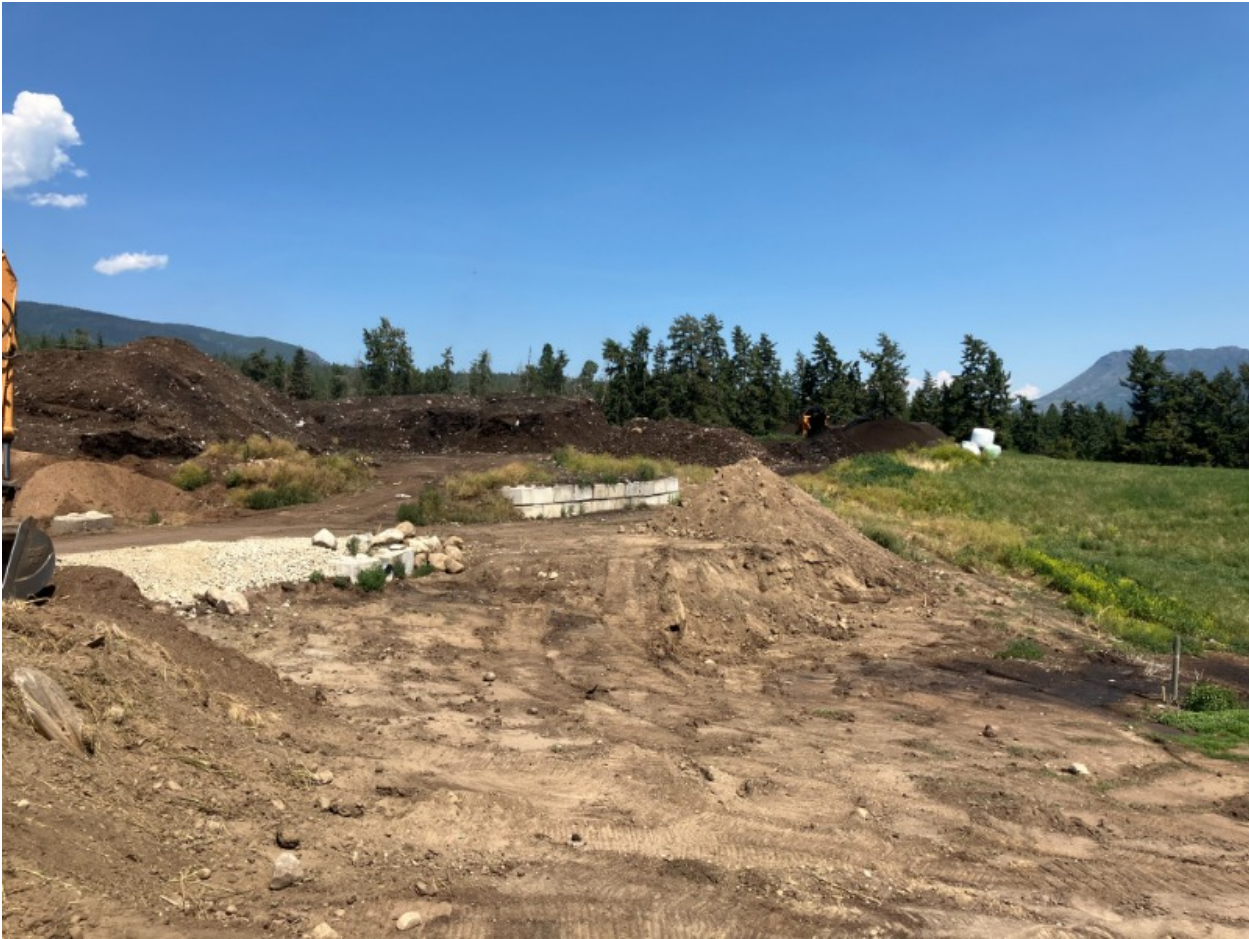
Photo 5. The storage area at the Facility did not have a roof, cover or a prepared surface designed to prevent the surface collection of water around the base of organic matter.

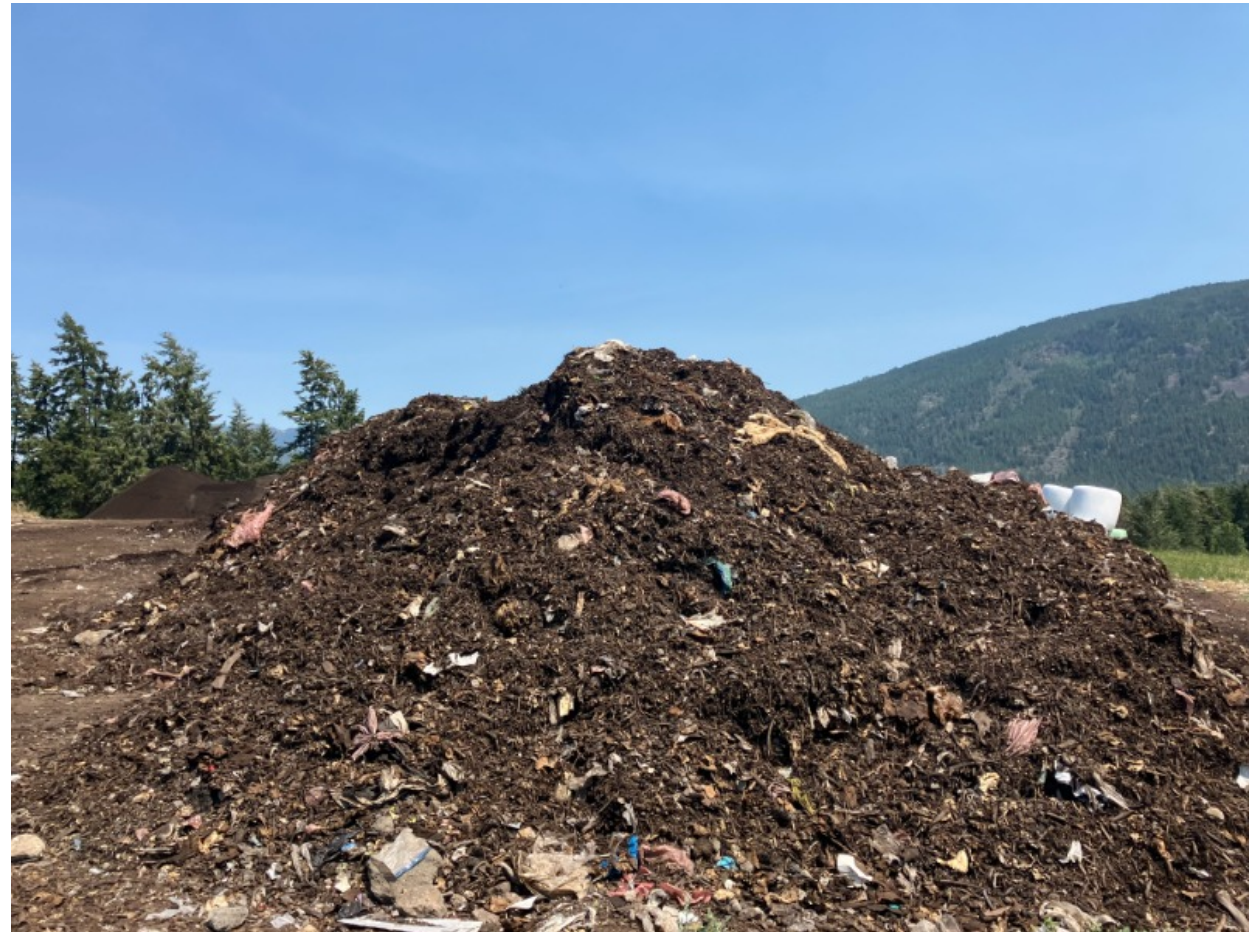
During the on-site inspection, Ministry Staff observed residuals from the composting operation out in the open. No actions or measures to prevent vector attraction were observed.

Photo 6. Residual piles, located north of the Facility exceeding 15 cubic metres.

Ensure residuals from the composting process are stored in a manner that prevents vector attraction.
