Report Date: September 17th, 2024

Report Number: 230350

Spa Hills Farm Inc.
2223 Yankee Flats Road SW,
Salmon Arm, BC

Re: Warning Letter

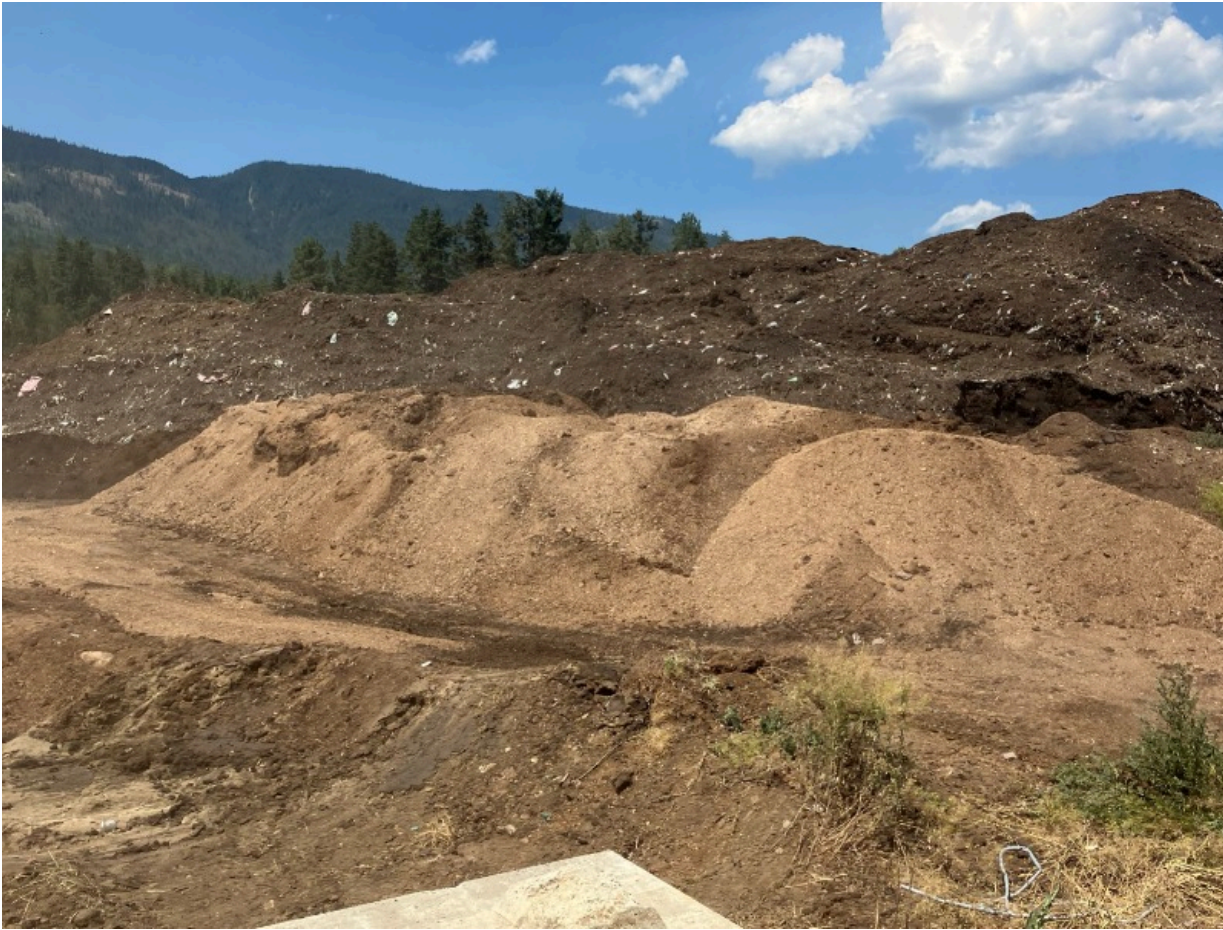
During the on-site inspection, Ministry Staff observed that Spa Hills stores agricultural by-products (including manure) in a temporary field storage (Photo 1). Ministry Staff observed (a) that any leachate generated during storage is not (i) collected or contained, and was discharge directly to land; (b) that runoff is not diverted away from the storage area; (c) that the storage area is not maintained to prevent contaminated runoff, leachate and solids from escaping; (d) that the contaminated runoff, leachate and solids that had escaped did not enter a water course or cross a property boundary. Ministry Staff could not verify that (e) air contamination from the stored agricultural by-products did not cross the property boundary. In addition, Ministry Staff did not observe (f) agricultural by-products that are stored were not stored in a manner that deters the attraction of, and access by, domestic pets, wildlife and vectors.

Photo 1. Stored agricultural by-products (including manure) in a temporary field storage in close proximity to compost operation.

Immediately cease the unauthorized discharge of leachate to ground and ensure the following:

- Collect or contain leachate from stored agricultural by-products and ensure there is no direct discharge to the land or water;
- Divert runoff from the stored agricultural by-products; and
- Maintain the stored agricultural by-products to prevent contaminated runoff, leachate, and solids from escaping.

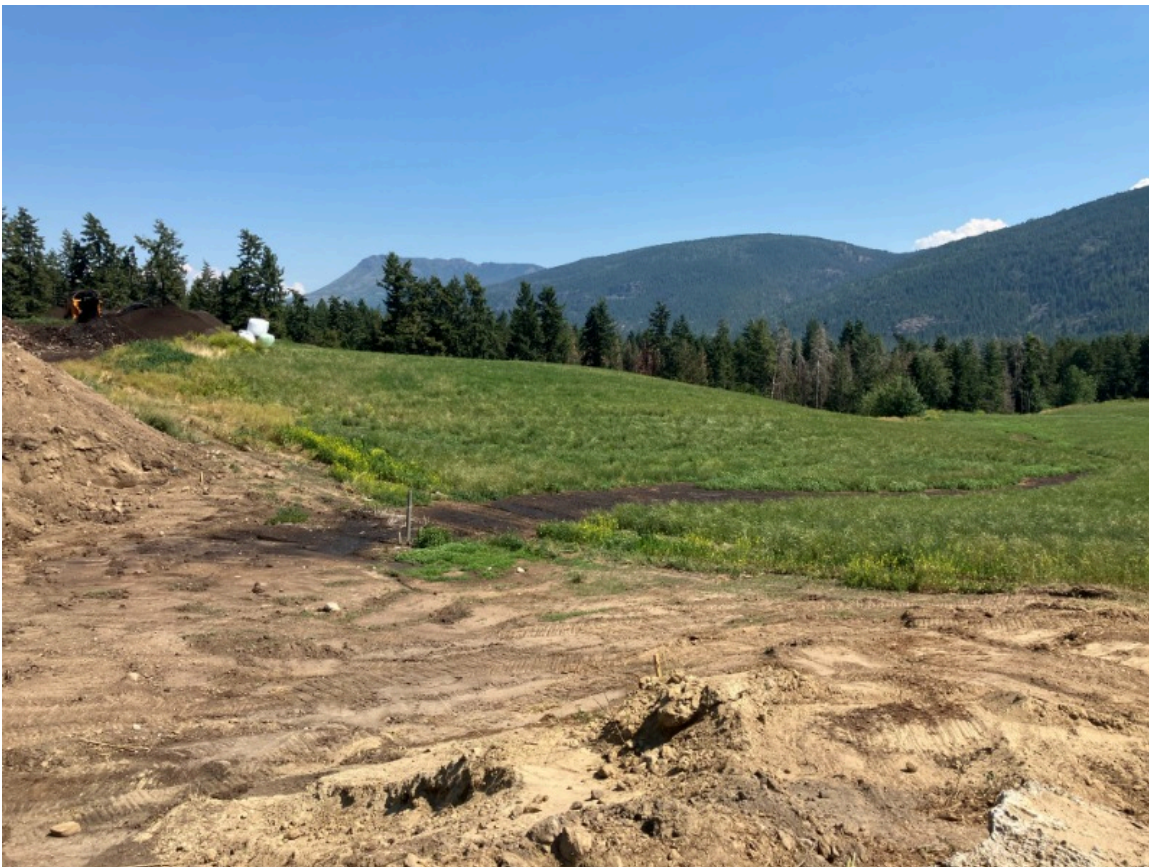
At the time of inspection, contaminated runoff and leachate from the stored agricultural by-products were observed entering a ditch on the property and being discharged to the ground which traveled along the property (Photos 2 and 3). Therefore Spa Hills is out of compliance for Sections 34 (a), (b), (c) and (f) of COPAEM.

Photo 2. Contaminated runoff and leachate, from the stored agricultural by-products, being discharged to the ground and travelling along the property.

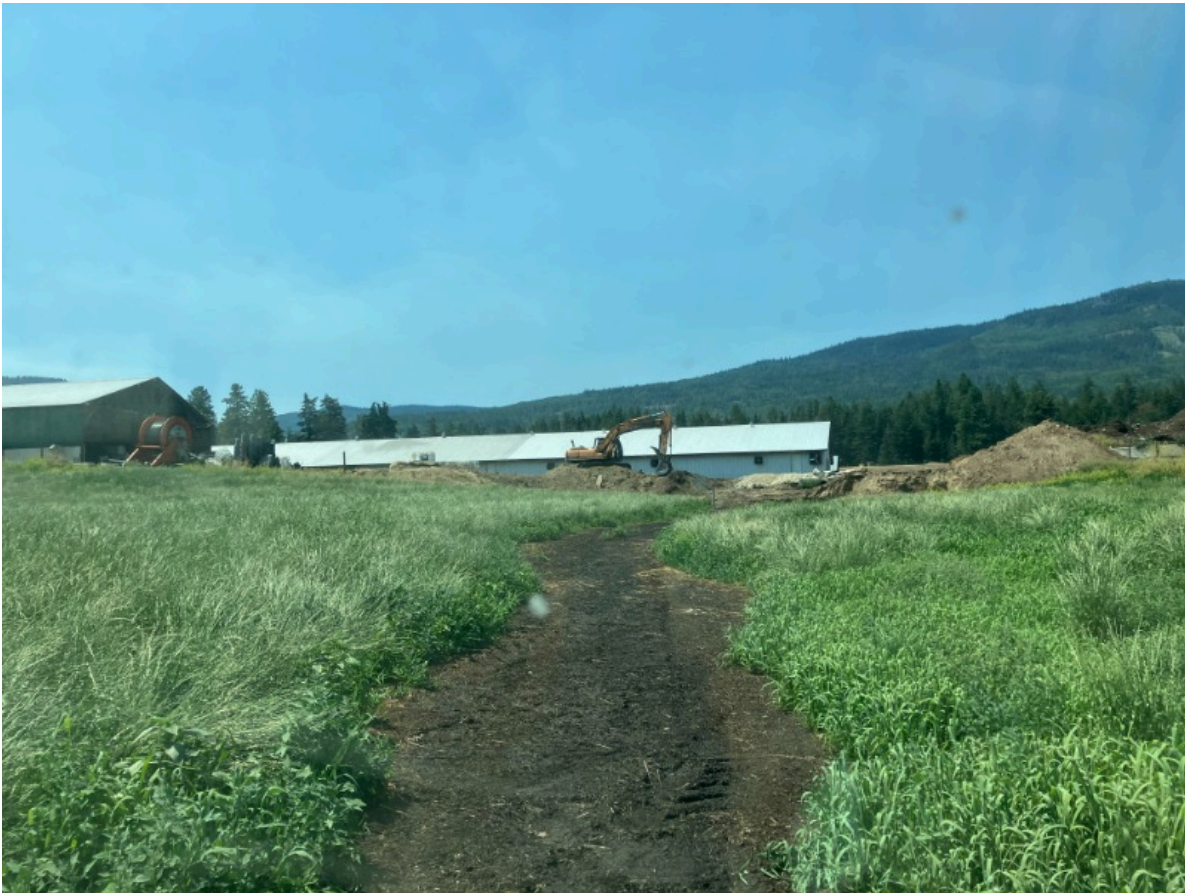
Photo 3. Contaminated runoff and leachate, from the stored agricultural by-products, being discharged to the ground and traveling along the property.

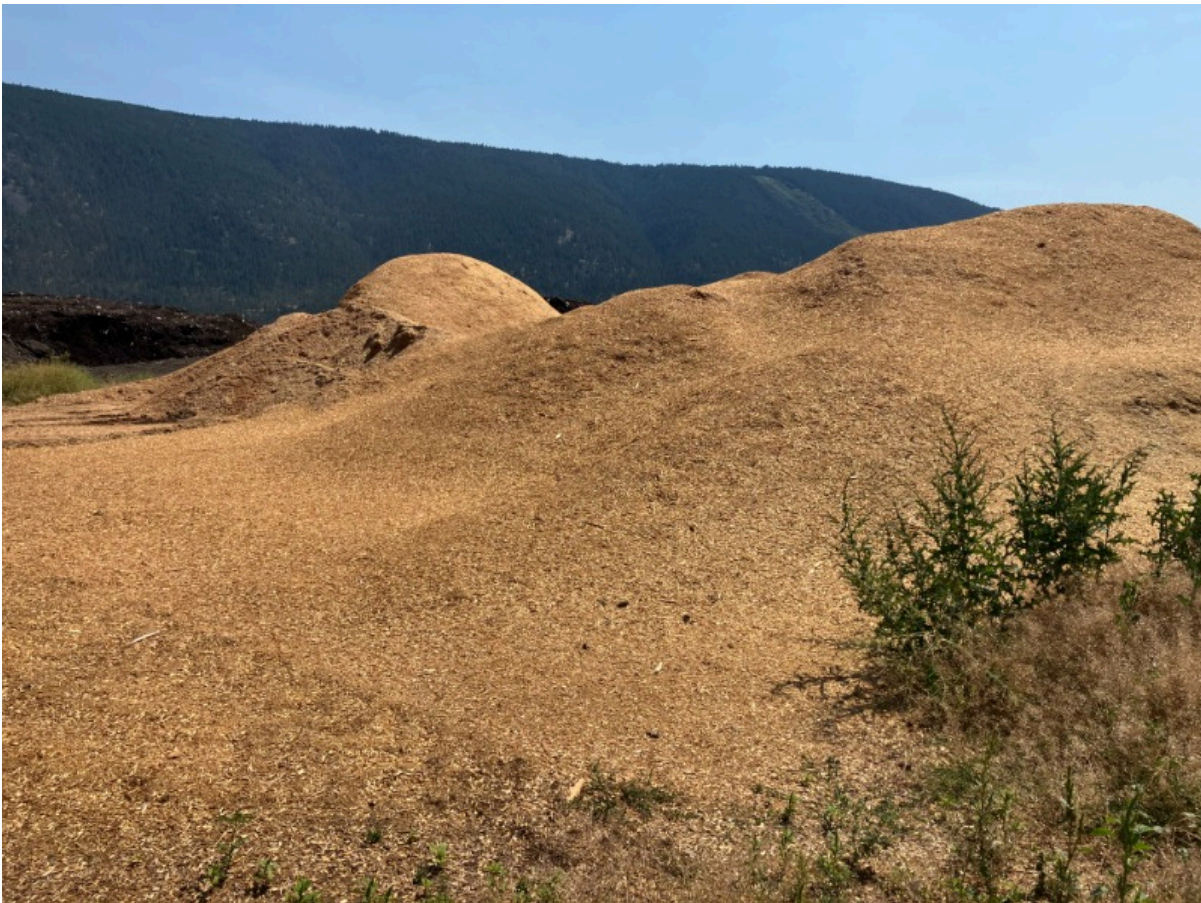
During the inspection, Ministry Staff observed wood residue, specifically sawdust, being stored at the north of the property (Photo 4). The Co-owner informed Ministry Staff, that the wood residue is brought onto the agricultural land base to be used as animal bedding and is stored in a temporary field storage for no longer than 6 weeks.

Photo 4. Wood residue being stored as temporary field storage at the north of the property.
