Report Number: 237307

Spa Hills Farm Inc.

2223 Yankee Flats Road, Salmon Arm, BC

Re: Warning Letter

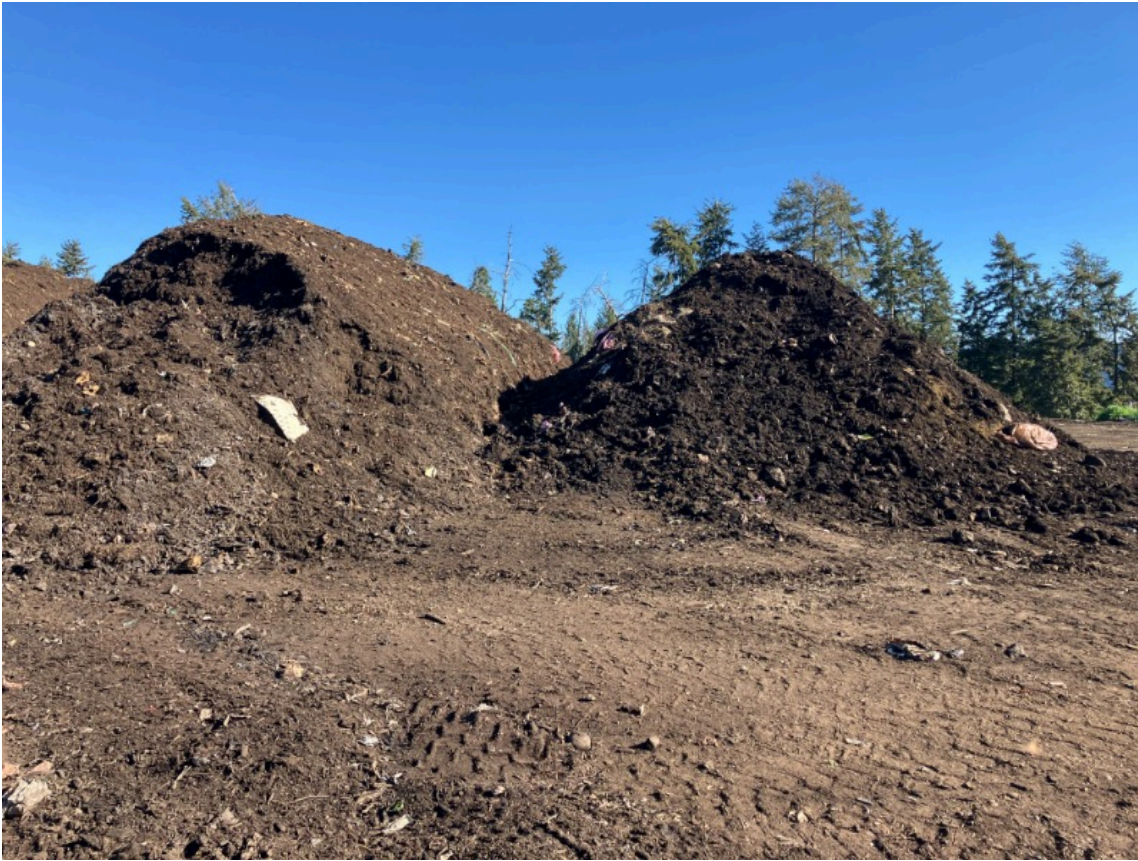
During the on-site inspection, Ministry Staff observed that receiving and curing areas of the composting facility were located on concrete to prevent the release of leachate into the environment. However, Ministry Staff observed that the compost storage, processing and screening areas at the north of the Facility appear to not be located on soil, this is not considered an impermeable surface that is capable of withstanding wear and tear from normal operations (Photos 7 and 8). It should also be noted that the storage and screening areas allows for effluent to be discharged to the ground. There was a effluent collection system in place, however the unlined ditch that flows into the surface water run-off collection pond consisted of soil. On May 7, 2025, Ministry Staff conducted water samples, the results are outlined in section 2 (5). which the results confirmed that the effluent exceeds one or more of B.C's ambient water quality guidelines for drinking water, protection of freshwater aquatic life, or wildlife.

Photo 1. Storage area at the Facility not located on an impermeable surface that is capable of withstanding wear and tear from normal operations and did not prevent the release of effluent.

Immediately cease the discharge of effluent into the environment. Spa Hills must ensure that the receiving, storage, processing and curing areas are located on an impermeable surface that is capable of withstanding wear and tear from normal operations.

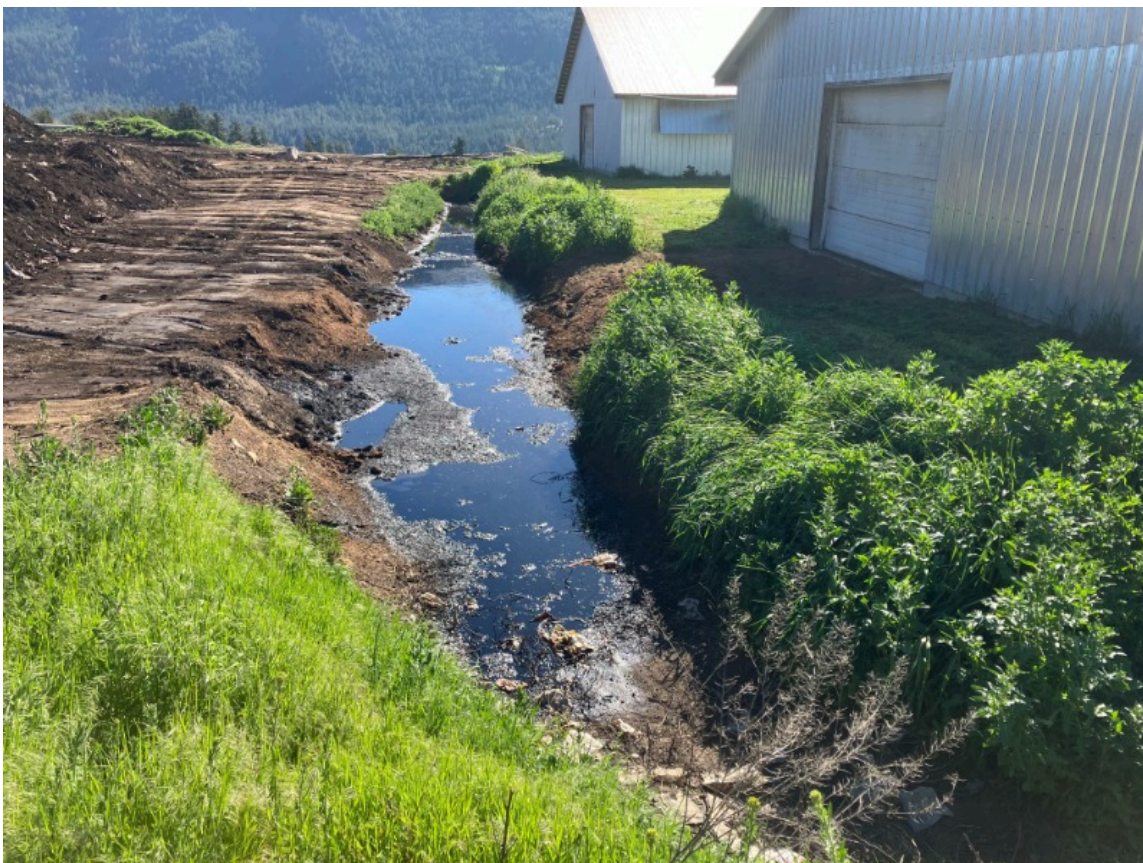
Photo 2. Unlined ditch to collect and direct runoff and excess precipitation from the compost storage area to the lined water containment.

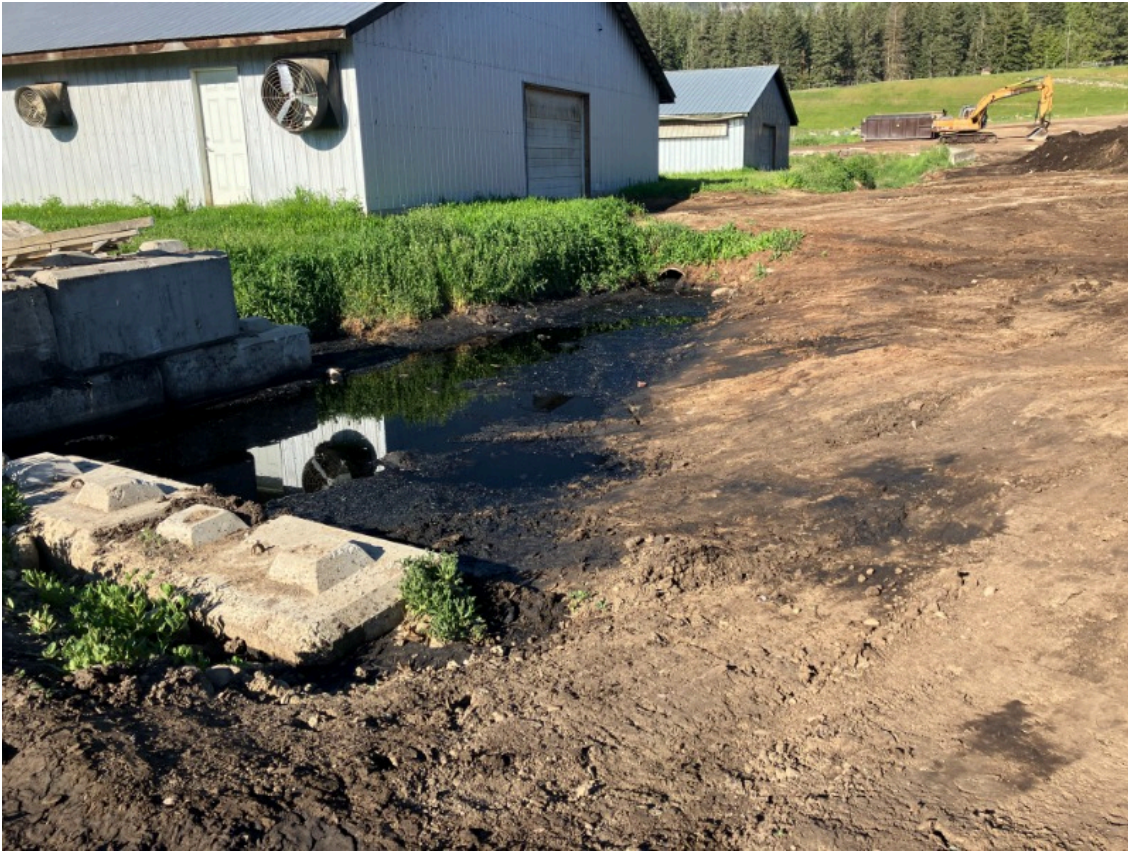
Photo 3. Unlined ditch to collect and direct runoff and excess precipitation from the compost storage area to the lined water containment.

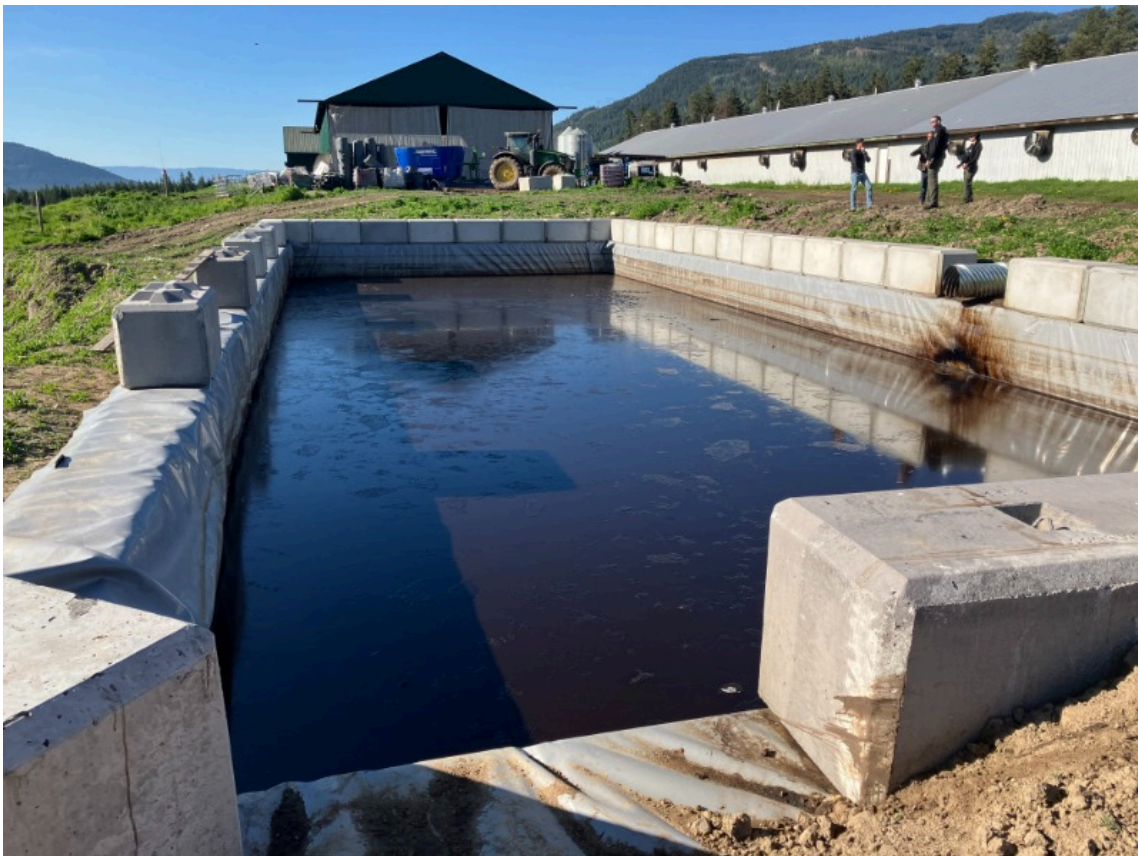
Photo 4. Lined water containment to collect runoff and excess precipitation from the compost storage area.

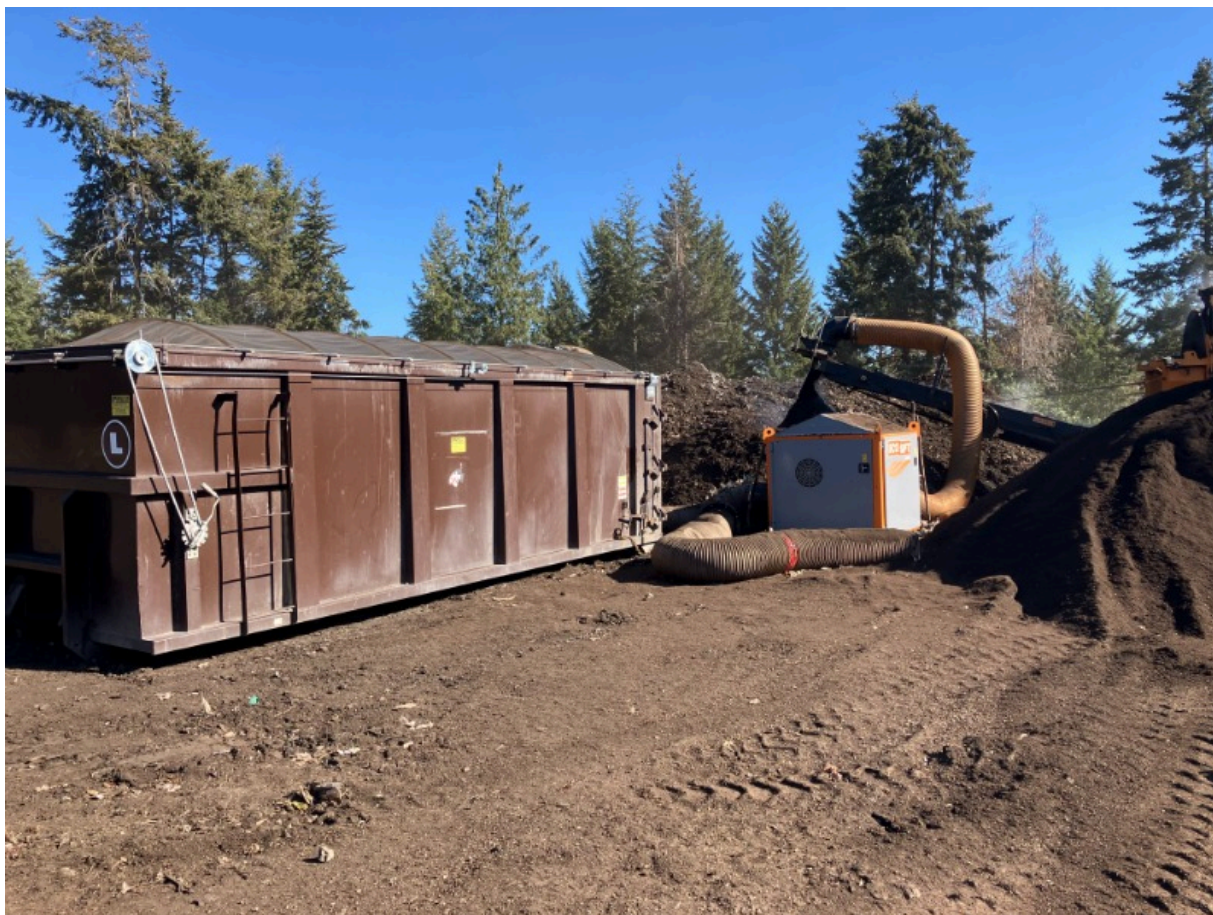
Photo 5. Residuals stored in a 15 cubic metre container, in a manner that prevents vector attraction.

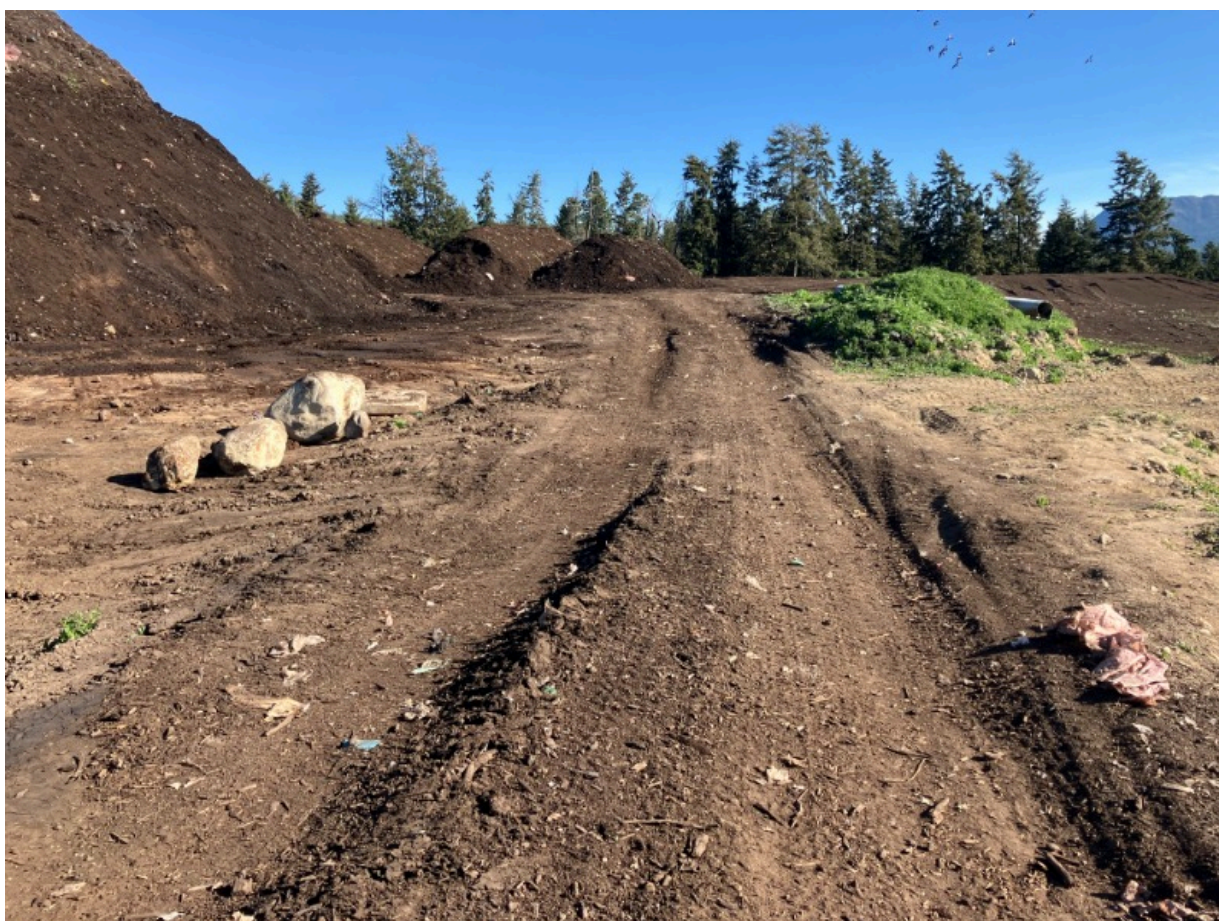
Ministry Staff observed that the receiving and curing areas of the composting facility were covered and on a prepared surface to prevent run-off from entering the areas. However, the storage and processing areas at the north of the Facility were not covered or on a prepared surface and run-off water has the possibility to enter the storage and processing areas.

Photo 6. Storage and screening areas at the Facility situated north of the property.

Ensure Spa Hills has a roof, cover or a prepared surface designed to prevent run-off water from entering the storage and processing areas.
